BATTERSON PARK POND DAM CT. 00262

PHASE I INSPECTION REPORT NATIONAL DAM INSPECTION PROGRAM

DECEMBER 1978

Identification Number:	CT 00262
Name:	Batterson Park Pond Dam
Town:	Farmington/New Britain
County and State:	Hartford County, Connecticut
Stream:	Piper Brook
Date of Inspection:	September 29, 1978

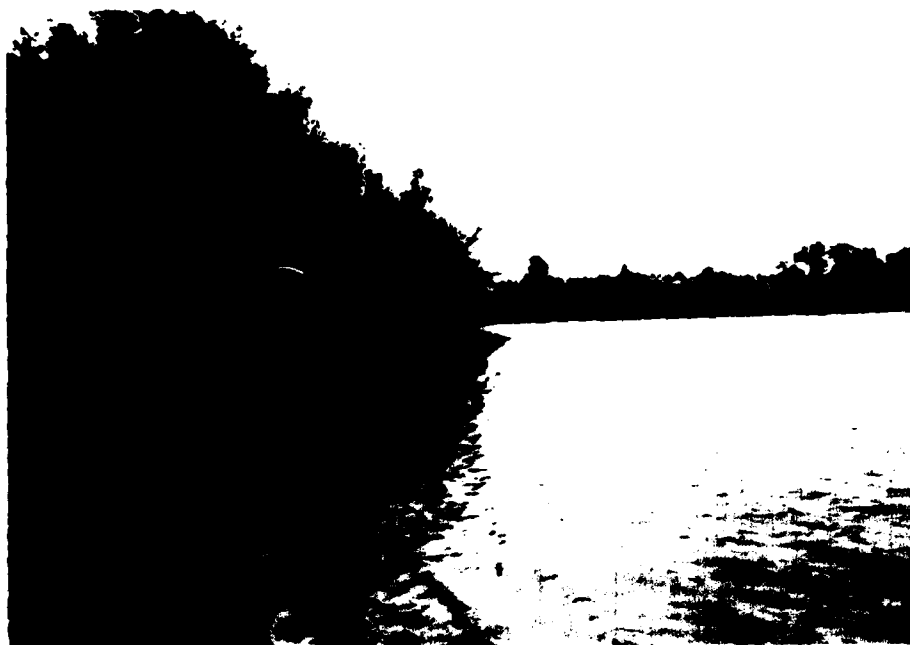
b. Dam - According to the data sheet supplied by the Metropolitan District Commission, Engineering Department, the body of the dam is composed of earth fill with a stone masonry core. The crest of the dam has a dirt road which is used by the maintenance section of the Parks and Recreation Department as well as mini-bikes and other recreational vehicles. The face of the dam is overgrown with vegetation and is irregular with several areas along the slope that have eroded. Several areas on the upstream face that had eroded were above the riprap protection and were several

PHOTO 1
UPSTREAM FACE OF DAM
